NORTHWEST REGIONAL MONITORING

Wirral Coastal Processes Report, 2017

Wirral Metropolitan Borough Council

August 2018

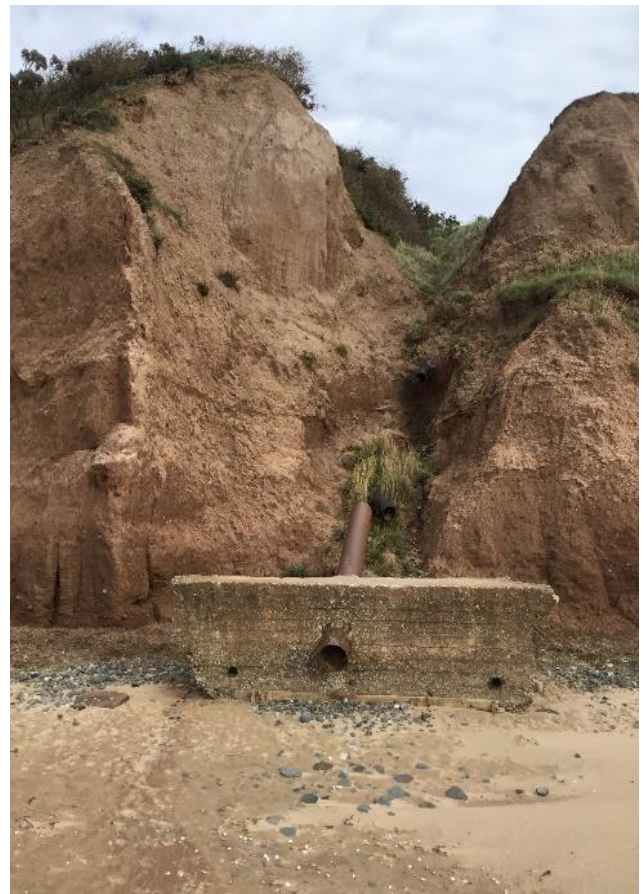
Figure 1: Eroding cliffs at Wirral Country Park, Dee Estuary Coast. (Photo Source: CH2M Site Visit 3rd October 2017)

1. Actual rates of cliff erosion along the undefended coast at Thurstaston are unknown. A limited number of beach profile surveys cover the cliff here, and these records only began in 2012. This leads to uncertainty over when properties and paths at the clifftop/cliff base will be at risk from erosion/damage.
2. The future of the Wirral's Dee Estuary shoreline is heavily dependent upon any changes in the tidal channels and banks, but the exact position of the channels is difficult to predict.
3. There is uncertainty whether the ongoing foreshore zone erosion at Caldy is being caused by the restriction of sediment supply by the cliff toe defences, or whether it is more driven by the effect

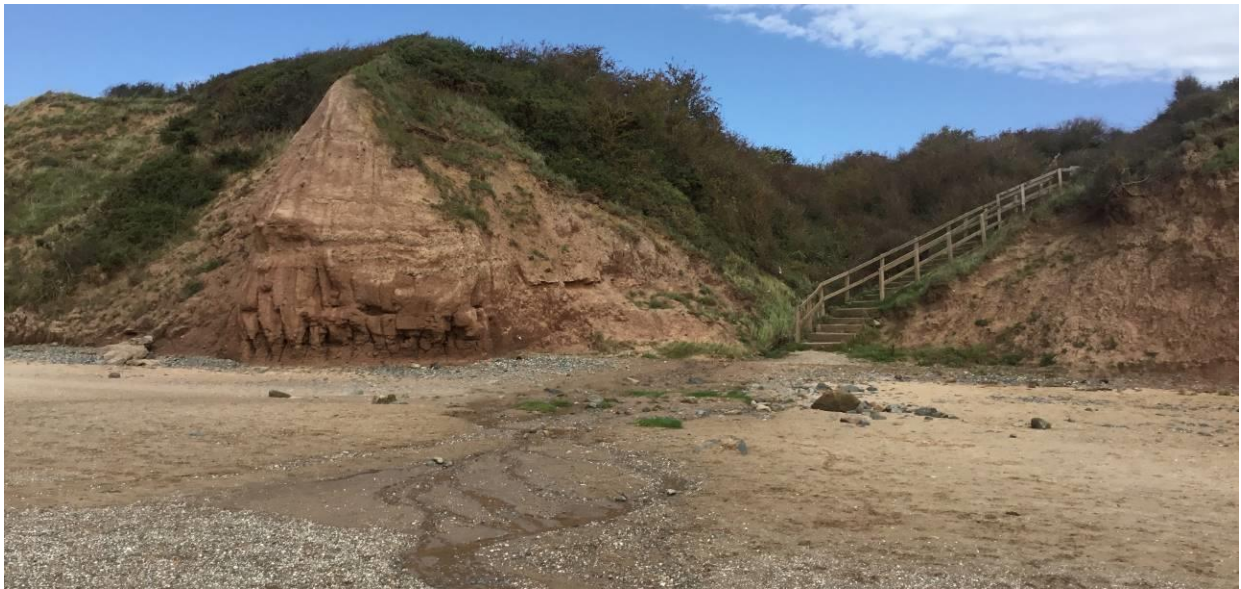
Figure 2: Un defended cliffs at Wirral Country Park (Photo Source: CH2M Site Visit 3rd October 2017)

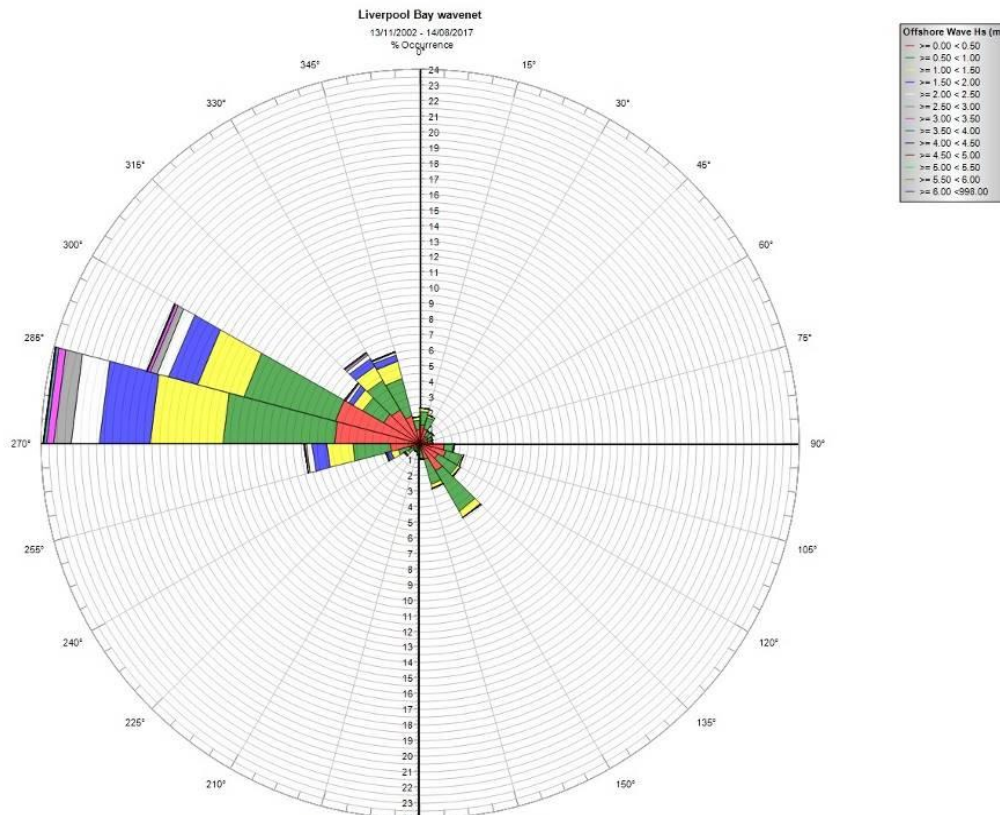
Figure 3 Wave rose for Liverpool Bay Wavenet wave data (13/11/2002 to 14/08/2017)

Waves in Liverpool Bay are measured by Liverpool Wavenet Buoy, located off Formby Point around 13 km north of the Wirral (see Appendix A). Wave measurements collected here over the past 15 years, displayed as a wave rose below, suggest that larger waves up to around 4 m in height mainly approach from the west, with some smaller waves up to around 2.5 m in height approaching less frequently from the northwest. There are sometimes smaller waves up to 1.5 m in height that come from the southeast, generated across the fetch of the River Mersey Estuary.

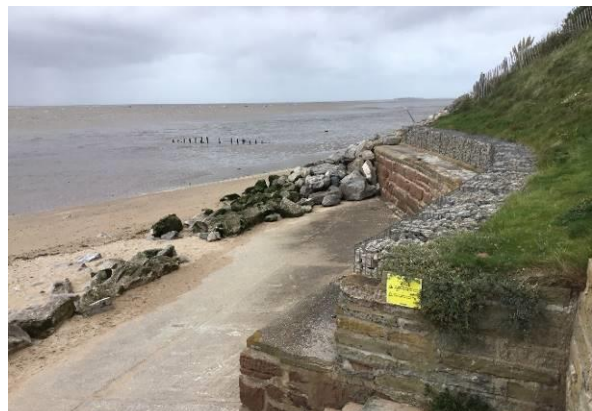
Figure 5 Cliff toe defences north of Thurstaston
(Photo Source: CH2M Site Visit 3rd October 2017)

Further north, the stretch of cliffs between Heswall and Thurstaston Causeway remains undefended; whereas various modifications have been made to try and slow the rate of cliff erosion to the north of Thurstaston Causeway, including cliff drainage, re-profiling and cliff toe protection. Since the 1980s, a rock toe revetment has protected most of the frontage between Thurstaston and West Kirby, with a short section of sloping concrete revetment at the northern end (Halcrow, 2010a).

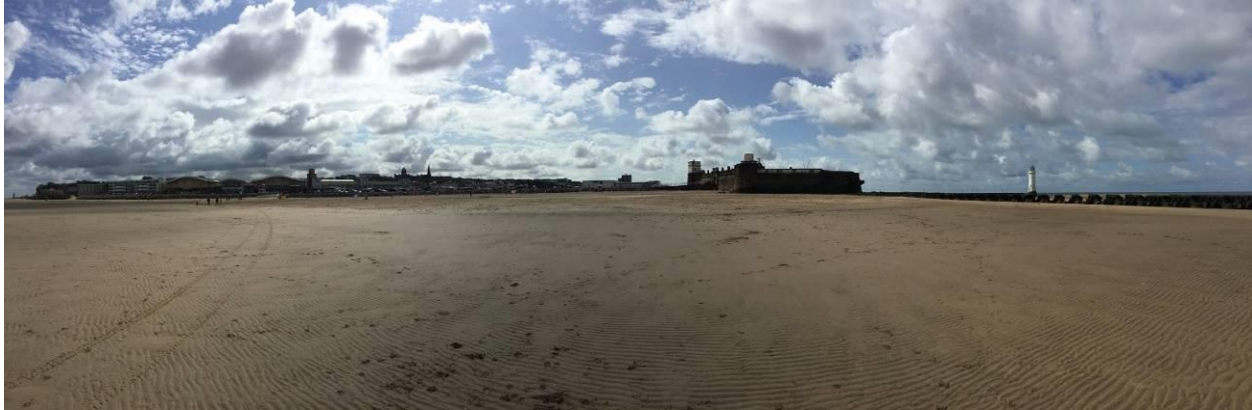
Figure 6: The intertidal area along the Mersey Estuary coast, looking landwards towards Fort Perch (Photo source: CH2M site visit, 1st September 2017)

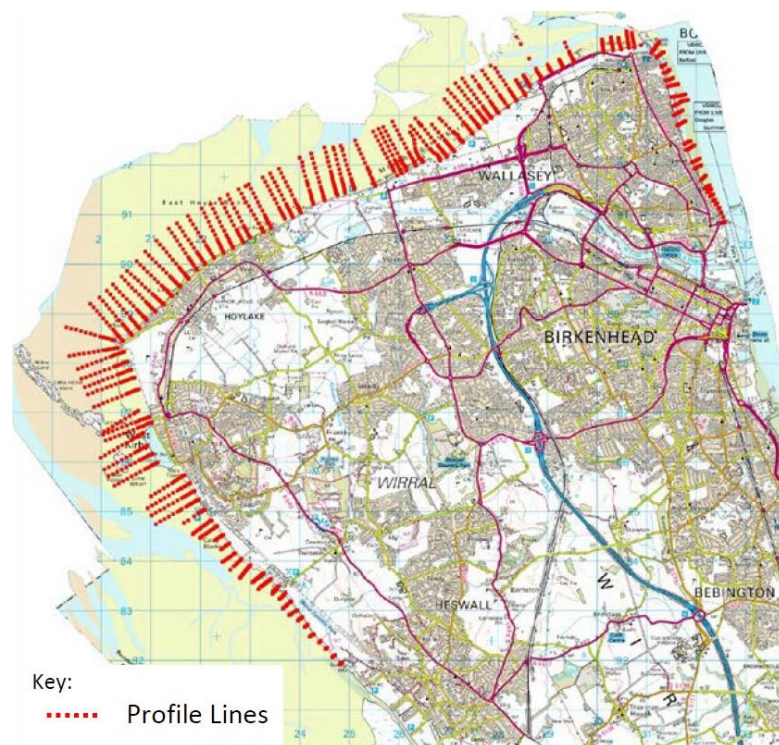
Figure 7: The location of the 133 beach profile lines along the Wirral coast. Image source: Sefton Council (2016) Background mapping provided by Ordnance Survey © Crown Copyright and database rights 2014 Ordnance Survey 100018192.

Beach profiles: These are cross-sections of the coast, determined by taking measurements of the ground surface elevation along a transect that runs perpendicular to the shoreline. Measurements usually extend from the backshore out to the level of Mean Low Water Springs (if conditions allow). The frequency of beach profile measurements collected along the Wirral coastline depends on the perceived level of risk: the higher the risk the more frequent the beach profile surveys, and some profiles are surveyed up to twice a year. The start date of monitoring for these profile lines is variable, with the earliest surveys dating to 1985. The locations of the profile lines are shown in Figure 7. **No beach profile data was available from 2017.**

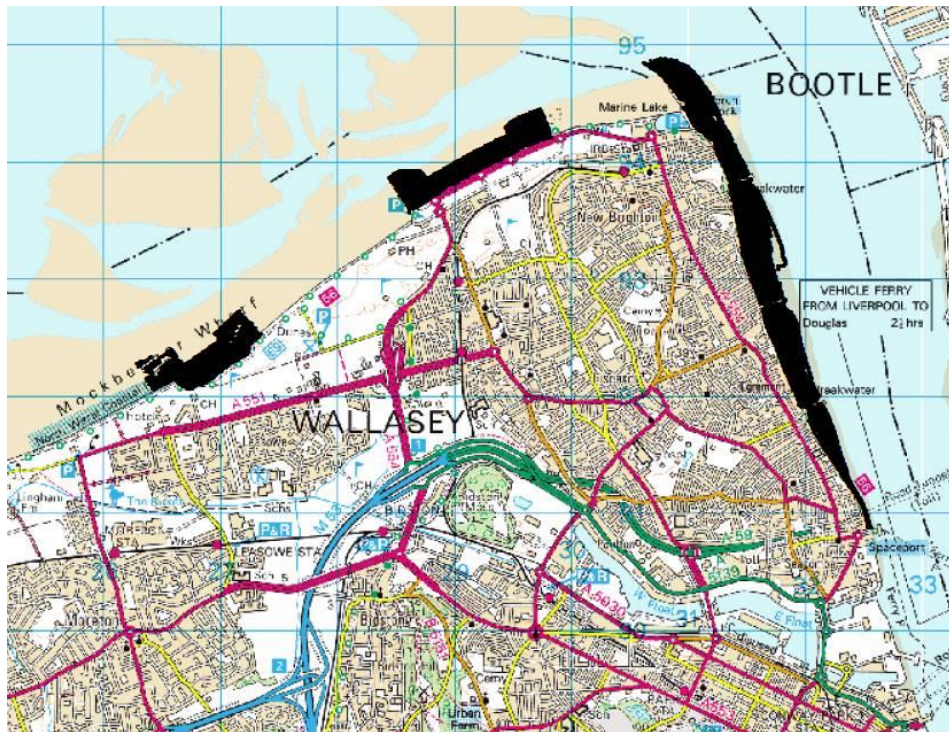
Figure 8: The locations of 3D topographic surveys (black areas) undertaken on the Wirral coast. Image source: Sefton Council (2016) with background mapping provided by Ordnance Survey © Crown Copyright and database rights 2014 Ordnance Survey 100018192.

The extent of the topographic surveys is shown in in Figure 8.

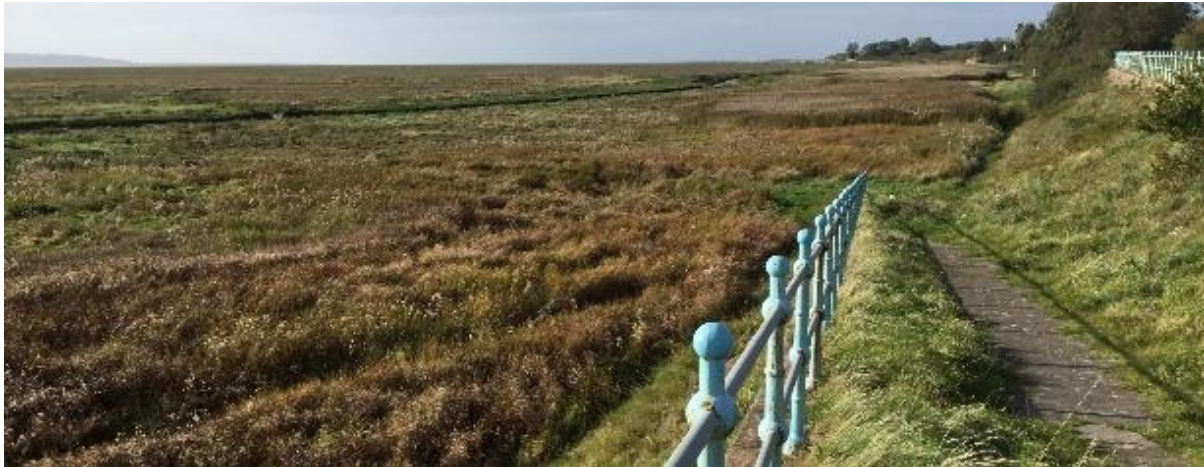
Figure 9: Saltmarsh at Riverbank Road, between Gayton and Heswall (Photo source: CH2M Site Visit on 3rd October 2017)

In the southeast of the frontage, between Gayton and Heswall (Figure 9), there has been steady accretion of the saltmarsh over the past ~30 years. This accretion may be continuation of the effects of extensive land reclamation in the upper Dee Estuary over the past three centuries, which has reduced the estuarine area by 27%, hence reducing the tidal prism (the volume of water within the estuary between the level of high and low tide), and causing sediment accretion within the estuary (Halcrow, 2012).

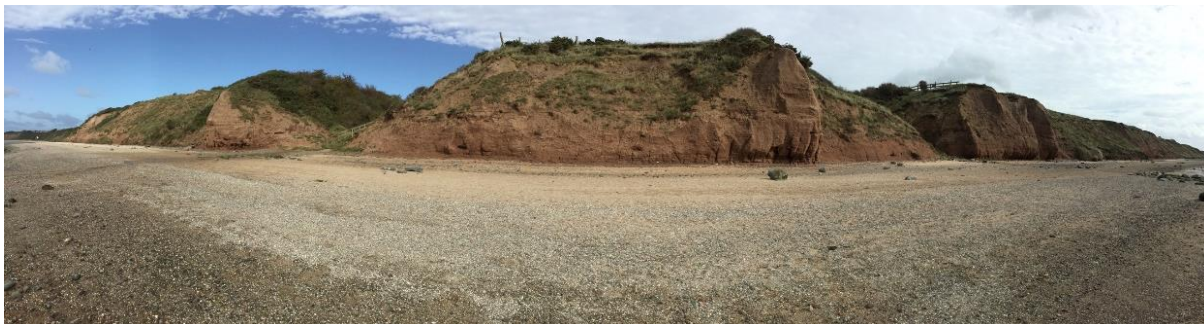
Figure 10: The undefended cliffs between Gayton and Thurstaston (Photo source: CH2M Site Visit on 3rd October 2017)

The undefended cliffs between Gayton and Thurstaston (Figure 10) have been eroding for the last 80 years (Halcrow, 2002) and recent beach profile monitoring since 2012 suggests continued sliding/slumping of the lower cliff. Cliff erosion directly south of Thurstaston has been reported to have been exacerbated due to the landward movement of a tidal channel that runs parallel to the shoreline and possibly also the interruption of longshore drift by Thurstaston Causeway, which restricts the supply of beach sediment to protect the cliff toe (Halcrow, 2010a).

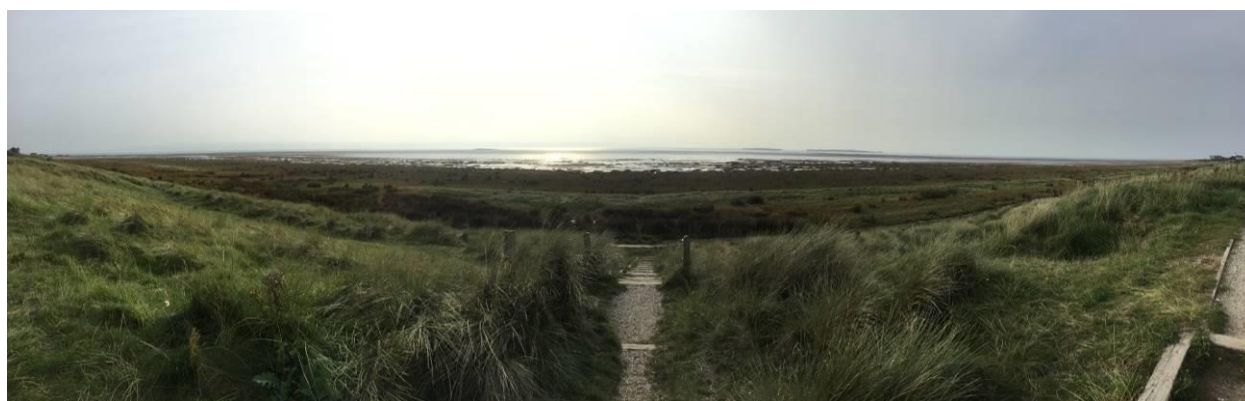
Figure 11: Saltmarsh colonising the foreshore between West Kirkby Marine Lake and Red Rocks (Photo Source: CH2M Site Visit 3rd October 2017)

The coast between the Marine Lake and Red Rocks has shown a considerable increase in beach levels across the intertidal zone over the past ~10 years, which may be linked to the changes in offshore sandbanks which have resulted from the artificial training of the main Dee Estuary channel (Halcrow, 2010a). In particular, the growth of East Hoyle Bank to the north (CEUK, 2013) is likely to be reducing the wave energy reaching the shoreline here, allowing sediment transported by tidal currents to accumulate in the intertidal zone. Saltmarsh is colonising the upper beach here, perhaps initiated by this reduction in wave energy and continuing via natural estuarine processes that enhance further trapping of finer sediment once saltmarsh plants become established.

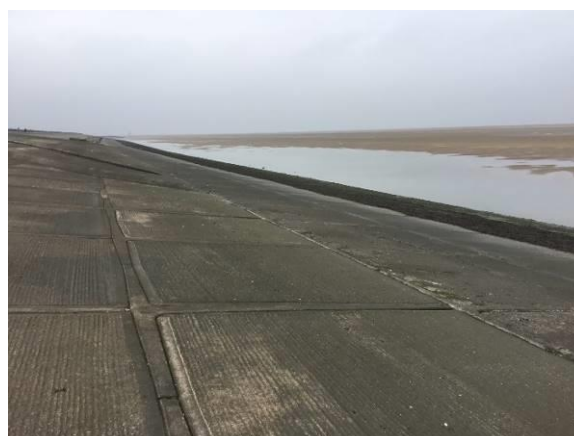
Figure 12: The Wallasey Embankment (Photo Source: CH2M Site Visit 29th September 2017)

During the 1840s, the Wallasey Embankment was constructed between Meols and Leasowe. During the 1970s and 1980s, the embankment was reconstructed and a new embankment was built on top of the old one for most of its length. The embankment was originally constructed to prevent the River Mersey from cutting a new route through the Wirral. The eastern end of the embankment is protected with an offshore rock armour breakwater (constructed 1981) which is now linked to the shoreline. A short shore-connected groyne has also been constructed at Dove Point to keep the Meols channel away from the toe of the defences (Halcrow, 2010a).

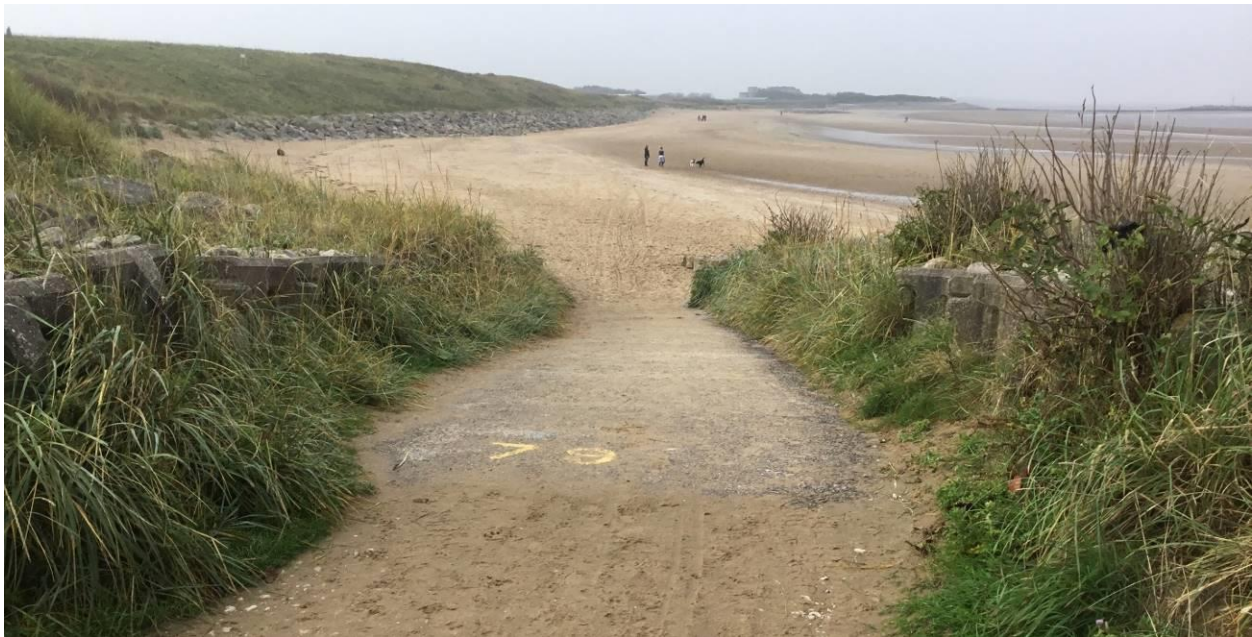
Figure 13: Sand dunes at Leasowe (Photo Source: CH2M Site Visit 29th September 2017)

- The sand dunes at Leasowe are the largest such system on the Wirral. Much of the area is at or below sea level and is protected by a coastal embankment. Spray overtopping causes flooding to the highway between New Brighton and Leasowe Revetment on most spring tide periods between October and April. Along the embankment are the remains of fortifications built during the Second World War. Coastal erosion and flooding would be detrimental to these features.

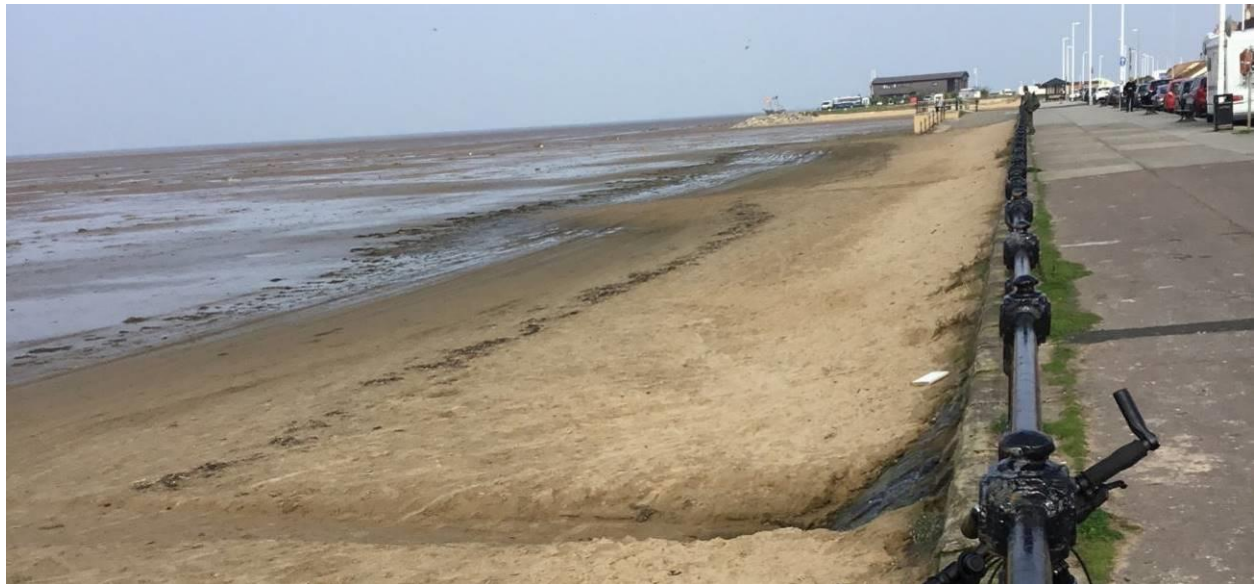
Figure 14: High beach levels next to the seawall at Hoylake (Photo Source: CH2M site visit 29th September 2017)

1. It is uncertain whether the recent accretions of sand against the seawall at Hoylake could increase the risk of overtopping during certain wave and water level conditions.
2. There is uncertainty surrounding the rates of accretion on this frontage and whether increasing sea levels may overtake the rate of accretion, hence reducing the area of intertidal zone and resulting in coastal squeeze against the hard defences (Halcrow, 2010a).

1. Investigate whether the high steep next to the wall at Hoylake increases the risk of overtopping of the seawall in certain wave and water level conditions (CH2M, 2016).
2. Undertake analysis of accretion rates and compare with sea level rise predictions to inform the required level of investment required to defend the frontage in the future (CH2M, 2016).
3. Monitor the accumulation of mud on the sandy foreshore near the RNLI station and assess whether it poses a public safety hazard (CEUK, 2013).
4. Monitor the algal growth on lower sections of the Wallasey Embankment, particularly between Bennets Lane and the Lingham Lane access, and assess whether it poses a public safety hazard (CEUK, 2013).

1. Investigate whether the high steep next to the wall at Hoylake increases the risk of overtopping of the seawall (CH2M, 2016).
2. Monitor the accumulation of mud on the sandy foreshore near RNLI station and assess whether it poses a public safety hazard (action brought forward from the monitoring report by CEUK, 2013).
3. Monitor the algal growth on lower sections of the Wallasey Embankment, particularly between Bennets Lane and the Lingham Lane access, and assess whether it poses a public safety hazard (CEUK, 2013).

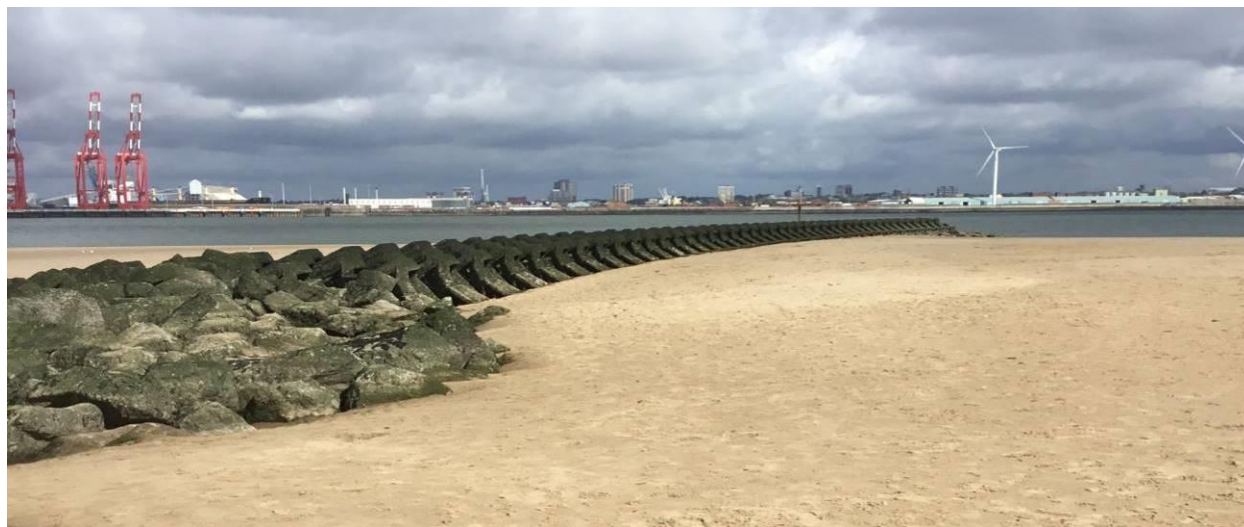
Figure 15: The shore-connected ‘reef-block’ breakwater with a rock stem at Fort Perch. (Photo Source: CH2M site visit 1st September 2017)

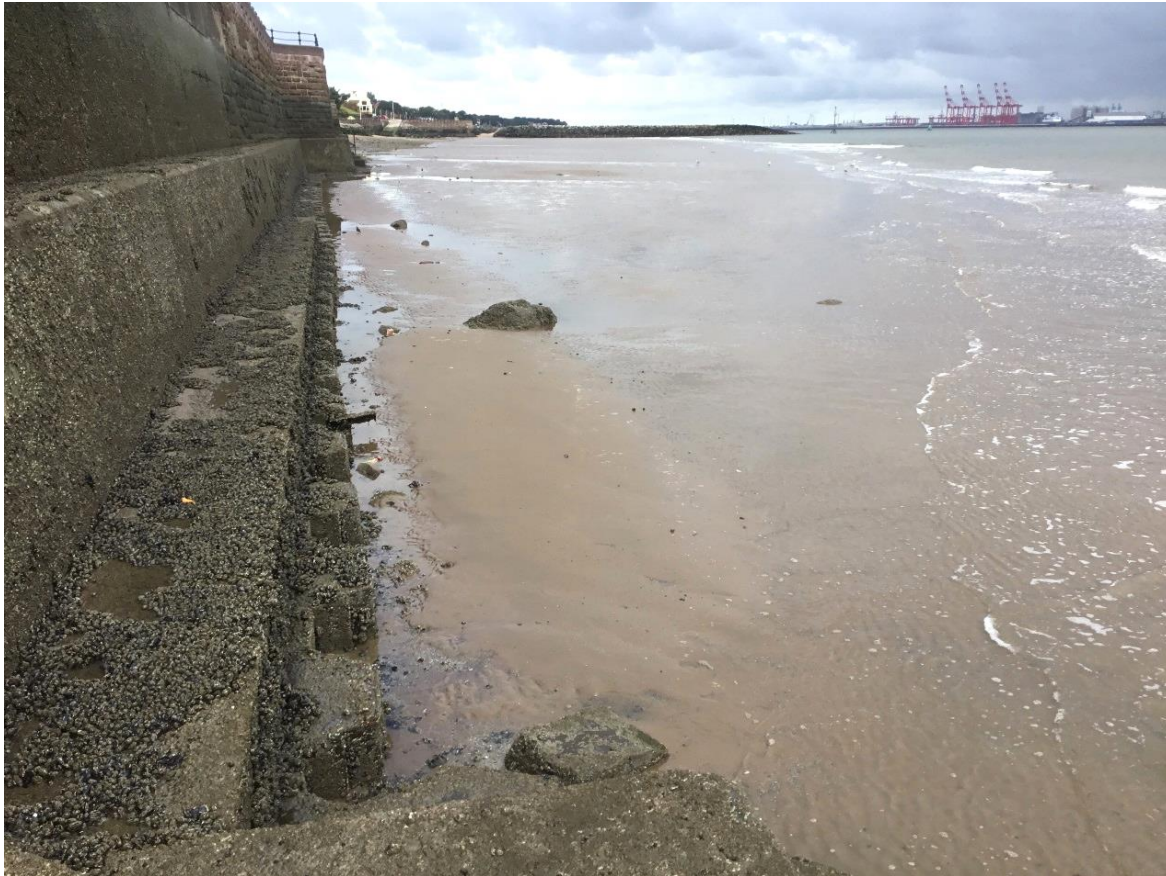
Figure 16: Low beach levels exposing sheet piling at the base of the seawall opposite Wilson Road, between Egremont Groyne and Seacombe Ferry (Photo Source: CH2M site visit 1st September 2017).

1. Beach levels are at historically low elevations at Wilson Road, Riverside School field and Lowry Bank, which may pose a hazard to the stability of the seawalls. These locations should be assessed by the Council to determine the level of risk and to determine if interventions are required.
2. There is limited data available on residual life of the defences (Halcrow, 2010a).
3. The overall response of the Mersey Estuary to sea level rise is uncertain. The supply of sediment to the estuary is expected to continue and will allow the estuary to accrete vertically in line with sea level rise. However, if sediment supply does **not** keep pace with sea level rise in the long term then erosion of the estuary margins may then occur (Halcrow, 2010a).

1. Opposite Wilson Road and between Riverside School field and Lowry Bank, compare recent beach levels at the seawall with known wall foundation elevations to assess whether low beach levels pose a hazard to the stability of the structure.
2. Monitor the algal growth on stepped beach access points and assess whether it poses a public safety hazard (CEUK, 2013).

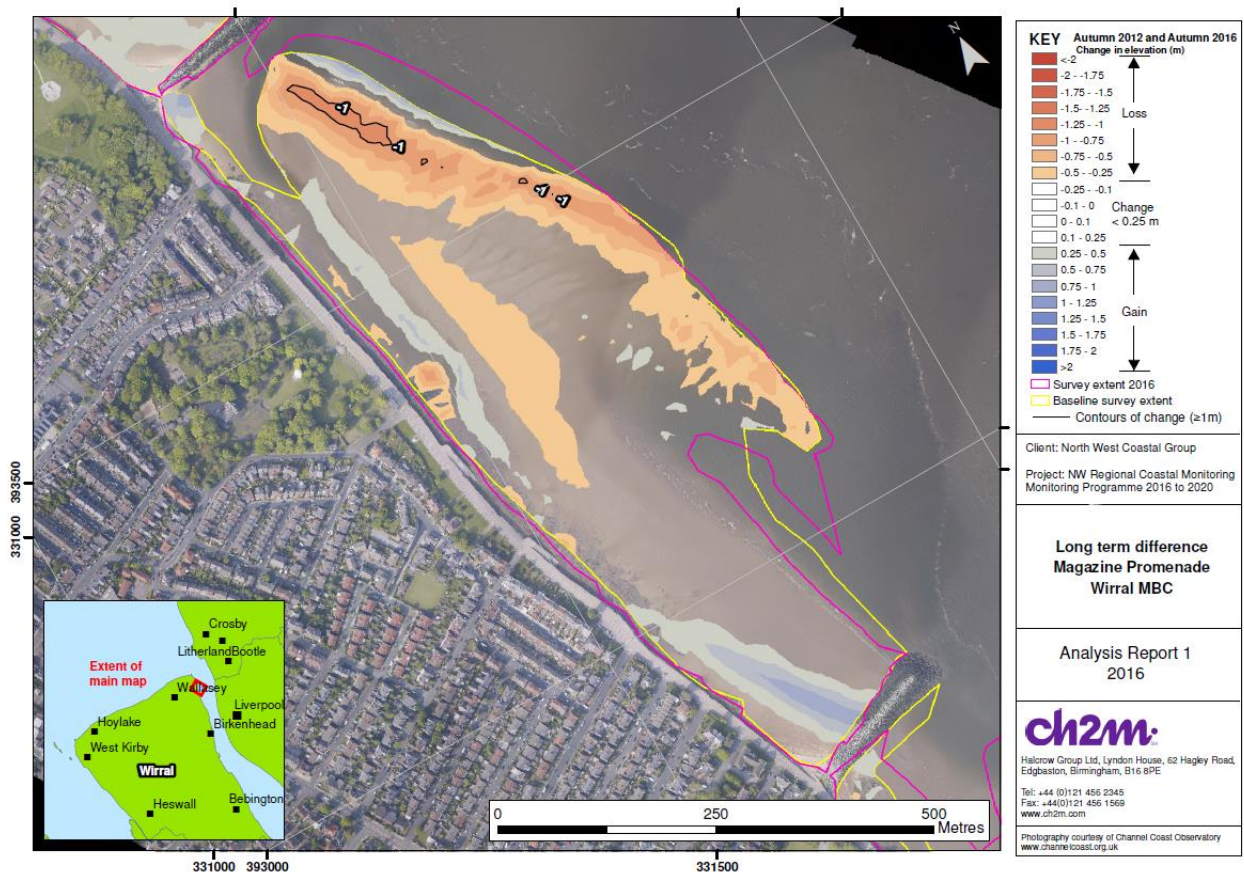
Figure 17: A topographic difference map for the frontage between Tower Groyne and Egremont Groyne which shows the difference in beach levels between Autumn 2012 and Autumn 2016. Red is erosion and blue is accretion.

Recent patterns of erosion and accretion appear to be mainly controlled by the influence that the groyne structures have on tidal currents and/or longshore sediment transport, as the monitoring in the past ~10 years shows a strong pattern of localised erosion on the south side of the groynes and accretion on the north side of the groynes (see Figure 17). Tidal currents are likely to be the dominant driver of sediment transport along this frontage where the flow becomes constricted in the narrow estuary mouth, and the strongest flows tend to be southwards because the estuary is flood-dominant (ABPmer 2005). Considering this, the erosion on the south side of the groynes may be caused by turbulence that the groynes create which acts to scour the sediment down-current. Alternatively, the groynes may block the predominantly southwards sediment transport to the area immediately south (downdrift) of the groynes. The sediment removed from the south sides of the groynes is then transported southwards and accumulates on the north (updrift) sides of the groynes.
